EFFICIENCY OF FILTER/COALESCER VESSELS FOR TRUCK RACKS

GAS PROCESSING PLANT IN THE BARNETT SHALE

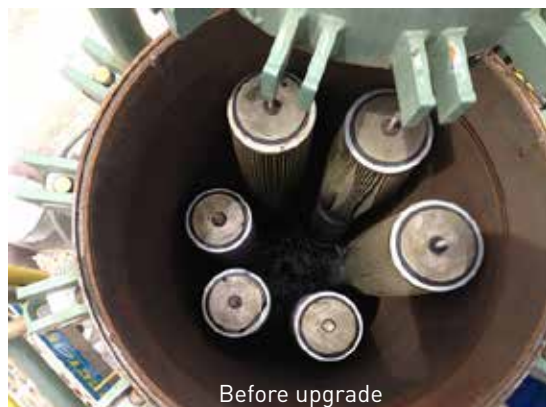
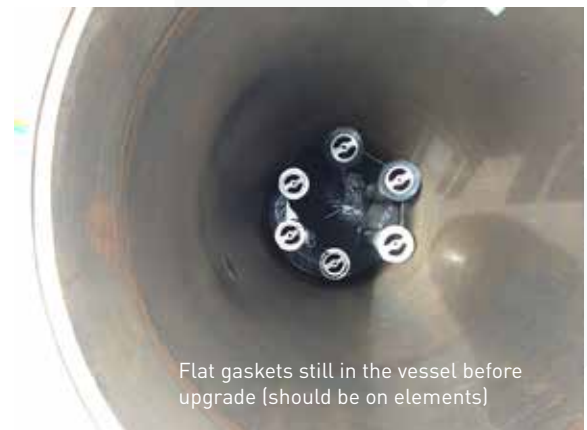
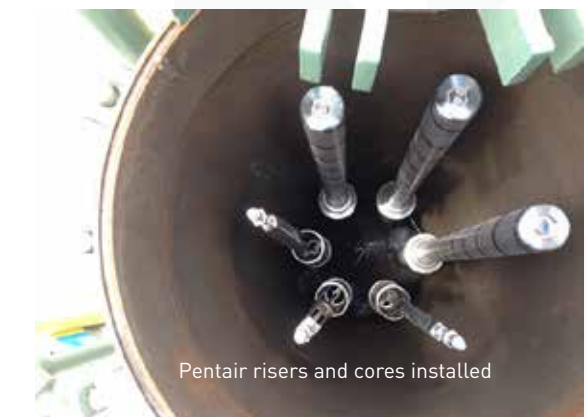
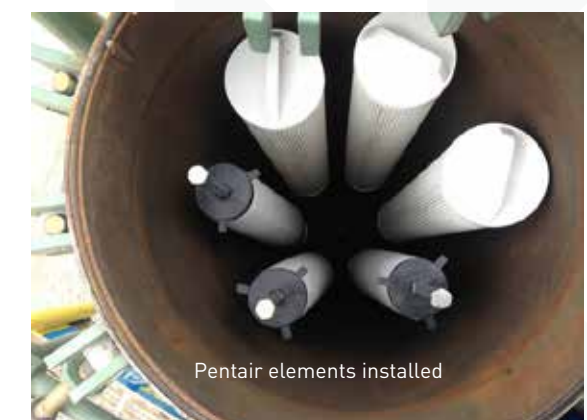
Pentair looked at the current separation elements being used due to issues with element integrity and online life. They were having issues with elements crushing on the outlet. Additionally, they were seeing bypass of the elements because the flat gasket seals would literally blow out. This can be seen in the before picture (bottom left photo and top right photo). Along with the element deficiencies, they were routinely skimming water out of their charge tank which should have been clean with the filter/coalescers upstream.

We have upgraded similar systems many times with great results. After speaking with the plant, they decided to move forward with upgrading both vessels to our Apex® technology on the Inlet side and Compax® technology on the Outlet side. The Apex element incorporates O-ring seals as opposed to flat gaskets to rid them of bypass issues. The Compax technology on the Outlet side fixed any issues with crushing by incorporating a very robust core the element slide over with an O-ring seal. The Compax technology also allowed them to get away from cumbersome hold down nuts.

The system is performing as designed, with improved life over the outgoing technology. Performance of the upgrade has now encouraged the client to look at a similar coalescer elsewhere in the plant that have been causing similar issues.
